Losantiville Avenue Safety Study

Village of Golf Manor, Ohio

PREPARED FOR:
Village of Golf Manor
6450 Wiehe Rd.
Golf Manor, Ohio 45237

PREPARED BY:
TEC Engineering, Inc.
7288 Central Parke Blvd.
Mason, Ohio 45040

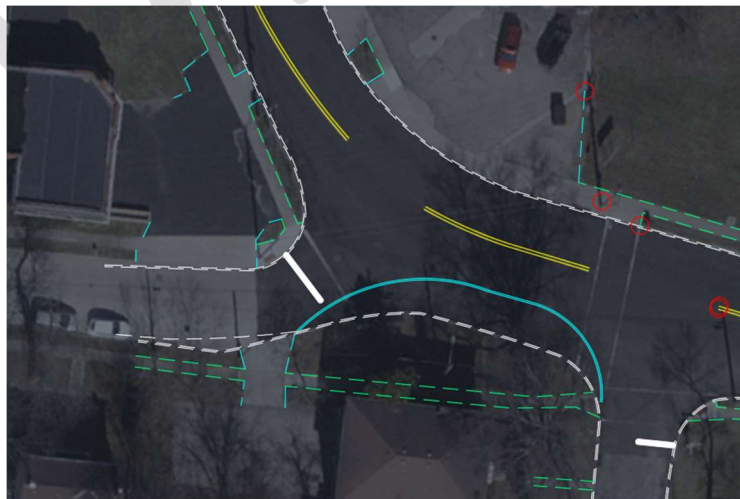
Widening/Curb Deflection @ Bremont/Englewood

The existing geometry of the Losantiville & Bremont intersection provides a direct/straight pathway for eastbound Bremont motorists onto eastbound Losantiville Avenue. The Village Police have indicated that this movement experiences poor stop sign compliance. Crash analysis did not indicate any crashes associated with stop sign compliance at this location, but improvements could be made to make the EB right from Bremont less direct. This would help reinforce the need to slow down and stop before making this movement. This improvement is shown conceptually shown below.

3. Bremont/Englewood intersection improvements – Revise overall pavement width to reinforce the required stop on Bremont. This improvement would also provide indirect speed calming due to tighter roadway widths. A shorter pedestrian crossing at Englewood could also be implemented which would reduce crossing time for pedestrians.
